**Flood Control Project Maintenance
Levee Inspections**

Maintenance Issue Types Only, Levee Inspection Report By Mile - Spring 2017

Sutter Maintenance Yard Tisdale Bypass

Waterway	Bank	Unit Miles	Inspection Start/End	Inspector
Unit No. 01 Tisdale Bypass	Left	4.51	04/07/2017 04/07/2017	Bob Duffey

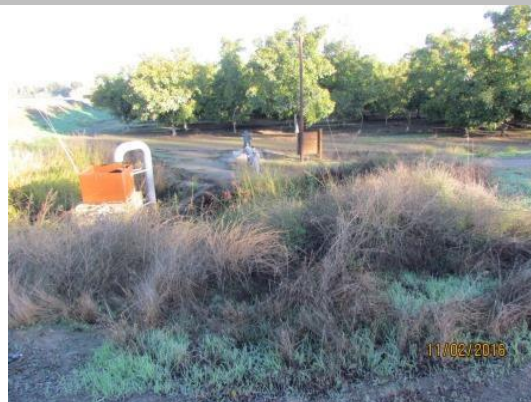
Photo 1 of 1 : SP_2017_ST0009_286_10_20170315_00002.jpg

LM Start	0.03	Rating **	M	Issue No.	10
LM End	0.03	Issue Type +	Ma	Location *	LS
Category	Earthen Levee			GPS Latitude/Longitude	
				Start	End
Item	Vegetation			39.027253 °	39.027253 °
				-121.821330 °	-121.821330 °
DWR ID	DWR_ST0009_01_f_2016_10				
Comment Code					
V1 : Control annual grass and weeds on the levee slopes and easements.					
Inspector Comment

View of grass taller than 12 inches blocking visibility.

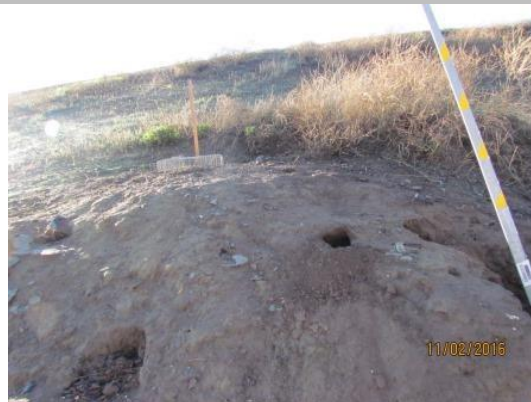
Photo 1 of 1 : SP_2017_ST0009_286_11_20170315_00003.jpg

LM Start	2.11	Rating **	M	Issue No.	11
LM End	2.11	Issue Type +	Ma	Location *	LS
Category	Earthen Levee			GPS Latitude/Longitude	
				Start	End
Item	Animal Control			39.028392 °	39.028392 °
				-121.782887 °	-121.782887 °
DWR ID	DWR_ST0009_01_f_2016_11				
Comment Code					
A3 : No rodents visible, but rodent burrows visible; need to backfill and compact or grout burrows.					
Inspector Comment

View of the rodent holes along the landside slope.

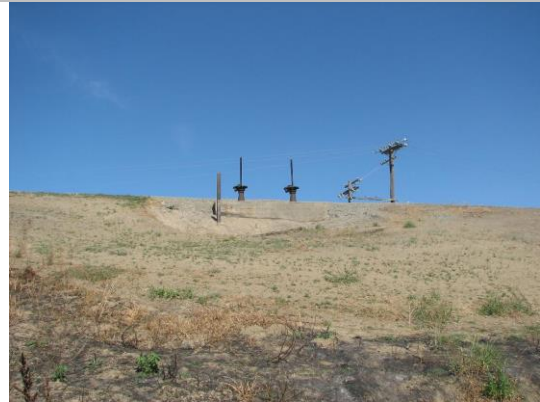
Photo 1 of 3 : UCIP_SP_2017_51484_64226.jpg

FS_ID:51484
DS_ID:16591
EP_NO: 10099
Repair Type: No Action Needed
Crossing Status: Found
UCIP Comments: 4/10/2017 Crossing appears to be in good condition.
(DWR Sutter Yard- AFreitag)10/11/2016 Crossing appears to be in good condition.
(DWR Sutter Yard - afreitag)4/18/2016 Crossing appears to be in good condition. No noticeable issues to report.
5/7/2015 Crossing is in good condition. No noticeable issues to report.
11/13/2014 Same as last inspection.5/12/2014 Same as last inspection.
10/30/2013 Same as last inspection.5/20/2013 Same as last inspection.
FIELD_STRUCT_DESC: 1 of 2: 48-inch by 84-inch (4-foot by 7-foot) reinforced concrete discharge tunnel through the levee, 38 feet below the crown. Slide gate in 4-foot by 15-foot concrete well on the waterside (WS) slope. Pump house located on the landside (LS) toe and wooden flap gates on the WS toe. (Automatic Board Order (ABO) issued as Permit No. 10099, 1955 - Reclamation District No. 1660). [Additional Reference(s): DWR Levee Log, 1993. USACE Sacramento O&M Manual 133, August 1955 (Station 1044+60)].

Slide gates on WS shoulder.

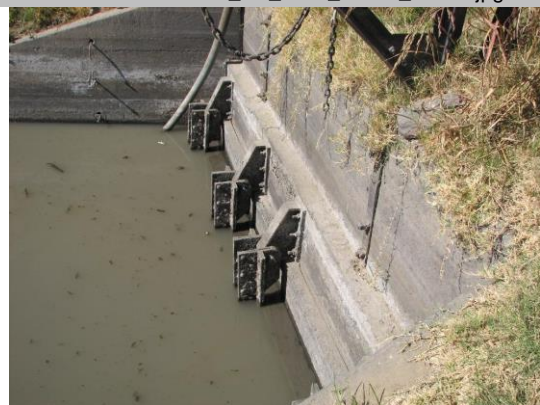
Photo 2 of 3 : UCIP_SP_2017_51484_64225.jpg

Wooden Flap gates on WS toe.

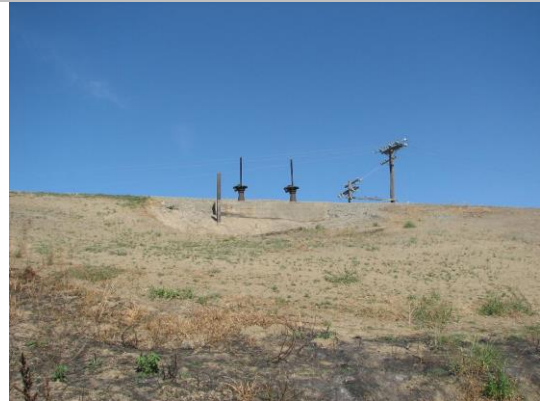
Photo 1 of 3 : UCIP_SP_2017_51485_64230.jpg

FS_ID:51485
DS_ID:16856
EP_NO: 10099
Repair Type: No Action Needed
Crossing Status: Found
UCIP Comments: 4/10/2017 Crossing appears to be in good condition.
(DWR Sutter Yard- AFreitag)10/11/2016 Crossing appears to be in good condition.
(DWR Sutter Yard - afreitag)4/18/2016 Crossing appears to be in good condition. No noticeable issues to report.
5/7/2015 Crossing is in good condition. No noticeable issues to report.
11/13/2014 Same as last inspection.
5/12/2014 Same as last inspection.
10/30/2013 Same as last inspection.
5/20/2013 Same as last inspection.
FIELD_STRUCT_DESC: 2 of 2: 48-inch by 84-inch (4-foot by 7-foot) concrete discharge tunnel through the levee, 38 feet below the crown. Slide gate in 4-foot by 15-foot concrete well on the waterside (WS) slope. Pumphouse located on the landside (LS) toe and wooden flap gates on the WS toe. (Automatic Board Order (ABO) issued as Permit No. 10099, 1955 - Reclamation District No. 1660). [Additional Reference(s): DWR Levee Log, 1993. USACE Sacramento O&M Manual 133, August 1955 (Station 1044+60)].

Slide gates on WS shoulder.

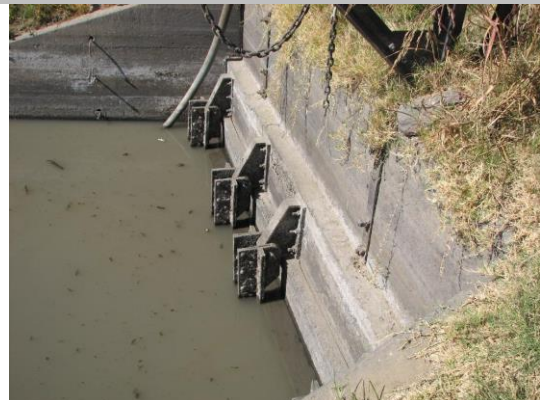
Photo 2 of 3 : UCIP_SP_2017_51485_64229.jpg

Wooden flap gates on WS toe.

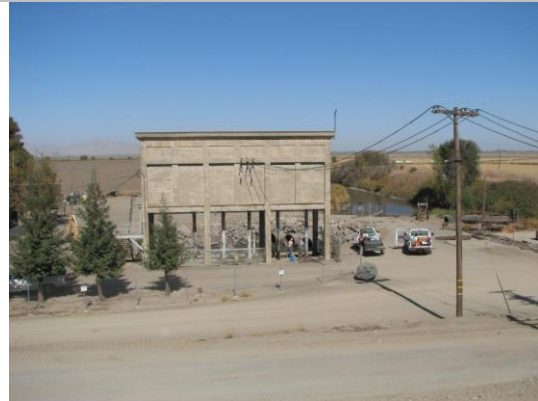
Photo 3 of 3 : UCIP_SP_2017_51485_64228.jpg

Pump house on LS toe.

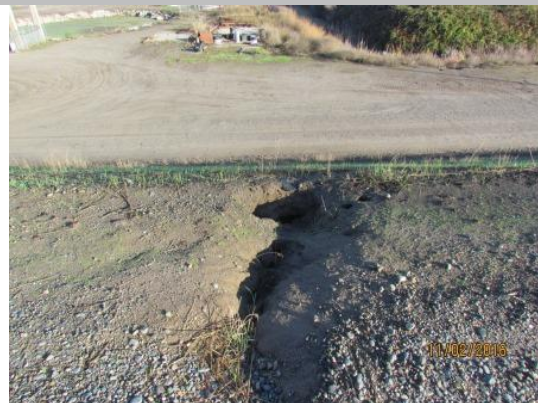
Photo 1 of 2 : SP_2017_ST0009_286_12_20170315_00004.jpg

LM Start	2.16	Rating **	U	Issue No.	12
LM End	2.16	Issue Type +	Ma	Location *	LS
Category	Earthen Levee			GPS Latitude/Longitude	
				Start	End
Item	Animal Control			39.028137 °	39.028137 °
				-121.782020 °	-121.782020 °
DWR ID	DWR_ST0009_01_f_2016_12				
Comment Code					
A3 : No rodents visible, but rodent burrows visible; need to backfill and compact or grout burrows.					
Inspector Comment

View of a rodent hole along the levee crown.

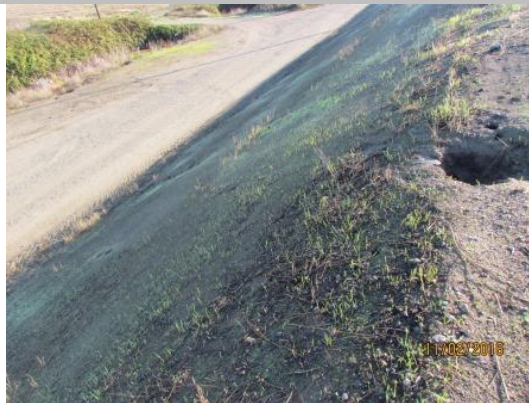
Photo 2 of 2 : SP_2017_ST0009_286_12_20170315_00005.jpg

LM Start	2.16	Rating **	U	Issue No.	12 (cont)	
LM End	2.16	Issue Type +	Ma	Location *	LS	
Category	Earthen Levee			GPS Latitude/Longitude		
				Start		End
Item	Animal Control			39.028137 °		39.028137 °
				-121.782020 °		-121.782020 °
DWR ID	DWR_ST0009_01_f_2016_12					
Comment Code						
A3 : No rodents visible, but rodent burrows visible; need to backfill and compact or grout burrows.						
Inspector Comment

Another view of the rodent holes along the crown and landside slope.

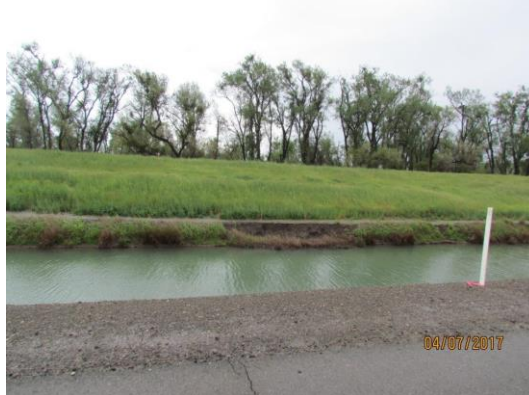
Photo 1 of 1 : SP_2017_ST0009_287_9_20170410_00016.jpg

LM Start	0.69	Rating **	M	Issue No.	9
LM End	0.71	Issue Type +	Ma	Location *	LS
Category	Earthen Levee			GPS Latitude/Longitude	
				Start	End
Item	Erosion / Bank Caving			39.025602 °	39.025657 °
				-121.808527 °	-121.808027 °
DWR ID	DWR_ST0009_02_s_2017_9				
Comment Code					
E2 : Schedule repair of erosion site prior to the next inspection.					
Inspector Comment					
Repair the erosion along the landside toe.

View of the erosion along the landside toe from the County Road.

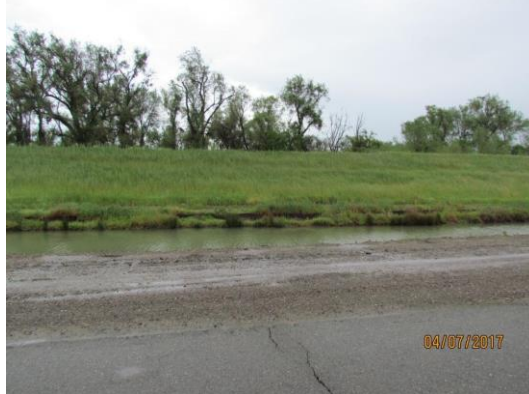
Photo 1 of 1 : SP_2017_ST0009_287_10_20170410_00017.jpg

LM Start	0.97	Rating **	M	Issue No.	10
LM End	0.98	Issue Type +	Ma	Location *	LS
Category	Earthen Levee			GPS Latitude/Longitude	
				Start	End
Item	Erosion / Bank Caving			39.025540 °	39.025572 °
				-121.803272 °	-121.802990 °
DWR ID	DWR_ST0009_02_s_2017_10				
Comment Code					
E2 : Schedule repair of erosion site prior to the next inspection.					
Inspector Comment					
Repair the erosion along the landside toe.

View of the erosion along the landside toe from the County Road.

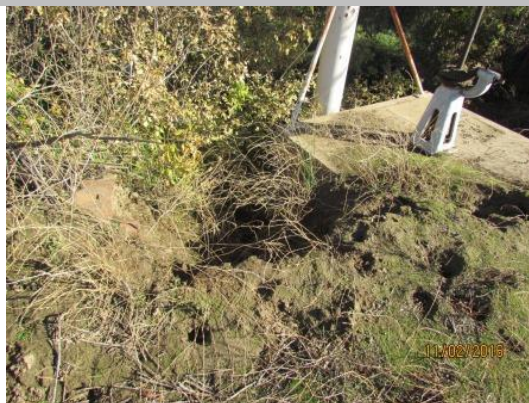
Photo 1 of 2 : SP_2017_ST0009_287_13_20170315_00005.jpg

LM Start	1.14	Rating **	M	Issue No.	13
LM End	1.14	Issue Type +	Ma	Location *	WS
Category	Earthen Levee			GPS Latitude/Longitude	
				Start	End
Item	Erosion / Bank Caving			39.025460 °	39.025460 °
				-121.800022 °	-121.800022 °
DWR ID	DWR_ST0009_02_f_2016_13				
Comment Code					
E2 : Schedule repair of erosion site prior to the next inspection.					
Inspector Comment					
Erosion around the WS concrete vault.

View of the erosion along the concrete vault.

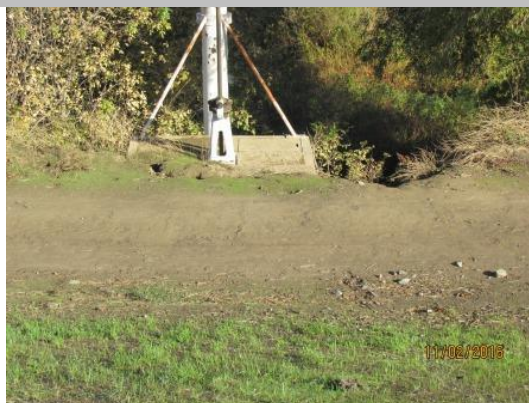
Photo 2 of 2 : SP_2017_ST0009_287_13_20170315_00006.jpg

Another view of the erosion along the concrete vault.

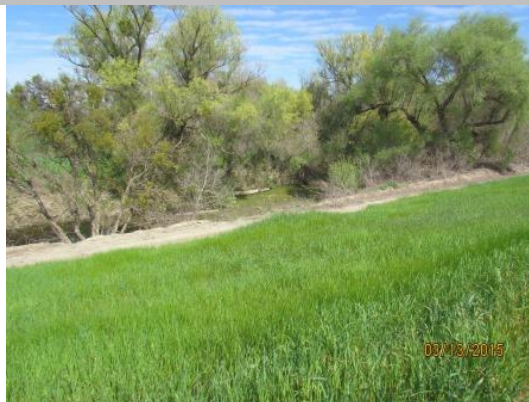
Photo 1 of 1 : SP_2017_ST0009_287_290_20170315_00007.jpg

LM Start	1.19	Rating **	M	Issue No.	290
LM End	1.19	Issue Type +	Ma	Location *	WS
Category	Earthen Levee			GPS Latitude/Longitude	
				Start	End
Item	Erosion / Bank Caving			39.025490 °	39.025490 °
				-121.799240 °	-121.799240 °
DWR ID	DWR_ST0009_02_s_2015_290				
Comment Code					
E1 : Note and monitor erosion site.					
Inspector Comment					
Sutter Yard needs to monitor the erosion along the berm.

View of the erosion along the waterside berm.

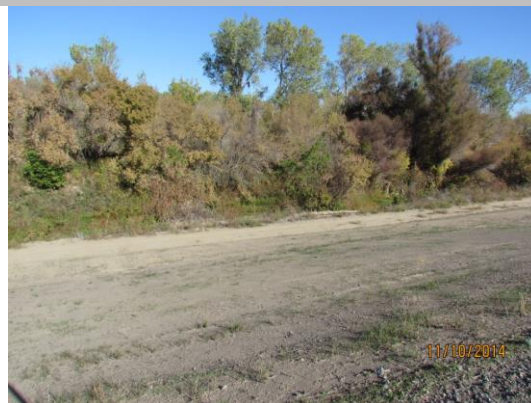
Photo 1 of 1 : SP_2017_ST0009_287_4_20170315_00003.jpg

LM Start	1.29	Rating **	M	Issue No.	4
LM End	1.29	Issue Type +	Ma	Location *	WS
Category	Earthen Levee			GPS Latitude/Longitude	
				Start	End
Item	Erosion / Bank Caving			39.025478 °	39.025478 °
				-121.797232 °	-121.797232 °
DWR ID	DWR_ST0009_02_s_2013_4				
Comment Code					
E2 : Schedule repair of erosion site prior to the next inspection.					
Inspector Comment					
Sutter Yard needs to monitor the erosion.

View of the erosion along the waterside berm.

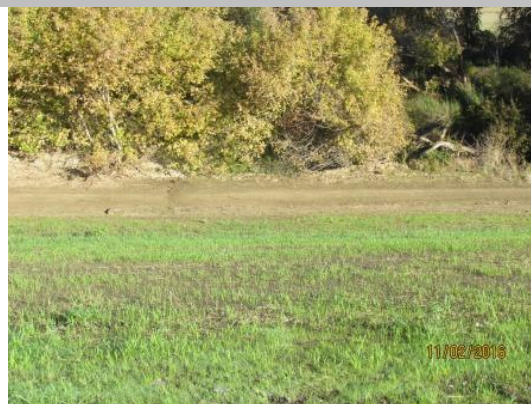
Photo 1 of 1 : SP_2017_ST0009_287_5_20170315_00004.jpg

LM Start	1.48	Rating **	M	Issue No.	5
LM End	1.50	Issue Type +	Ma	Location *	WS
Category	Earthen Levee			GPS Latitude/Longitude	
				Start	End
Item	Erosion / Bank Caving			39.025460 °	39.025446 °
				-121.793815 °	-121.793347 °
DWR ID	DWR_ST0009_02_s_2013_5				
Comment Code					
E2 : Schedule repair of erosion site prior to the next inspection.					
Inspector Comment					
Sutter Yard needs to monitor the erosion.

View of the erosion along the waterside berm.

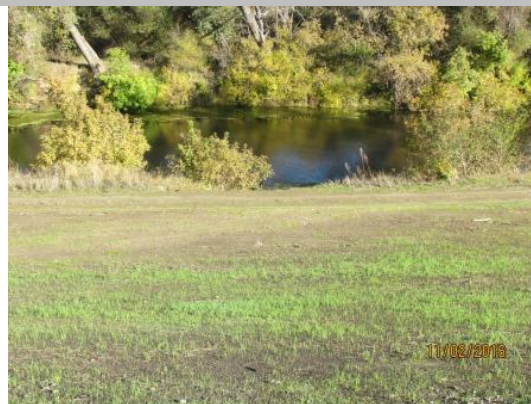
Photo 1 of 1 : SP_2017_ST0009_287_2_20170315_00002.jpg

LM Start	3.93	Rating **	M	Issue No.	2
LM End	3.93	Issue Type +	Ma	Location *	WS
Category	Earthen Levee			GPS Latitude/Longitude	
				Start	End
Item	Erosion / Bank Caving			39.025060 °	39.025060 °
				-121.748178 °	-121.748178 °
DWR ID	DWR_ST0009_02_f_2016_2				
Comment Code					
E1 : Note and monitor erosion site.					
Inspector Comment

View of the erosion along the waterside berm.
